Anywhere Drive, North Bay, CA
Inspection prepared for: John Sample
Date of Inspection: 6/1/2015

Inspector: John Marshall
Building Inspector # 5073014 | General Contractor License # 646931
Vallejo, CA 94591
Phone: 707-649-8700
Email: john@northbayinspection.com
<http://www.NorthBayInspection.com>

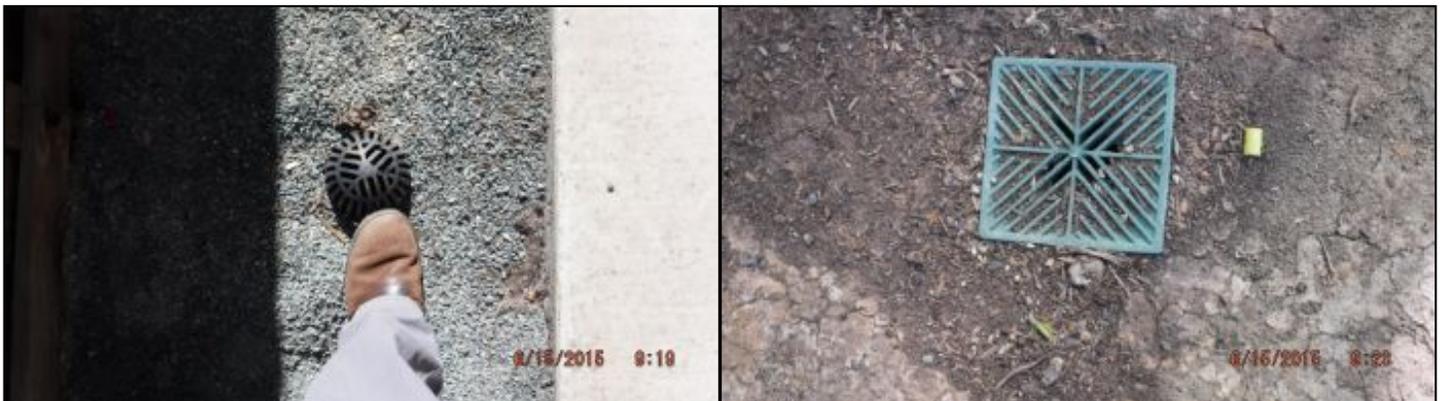
- This home has surface drains. These drains can be effective in reducing ponding and controlling surface water and runoff. It is not uncommon to have catch basins fill with debris and become ineffective. We recommend that all surface drains be tested periodically by using a garden hose and check the low point or discharge termination. Some systems have separate systems for the downspouts and surface drains, however most systems are dual function. It is important to check this system every fall. Excess water near the perimeter of the home can adversely affect the foundation.

home has surface drains

surface drains clogged

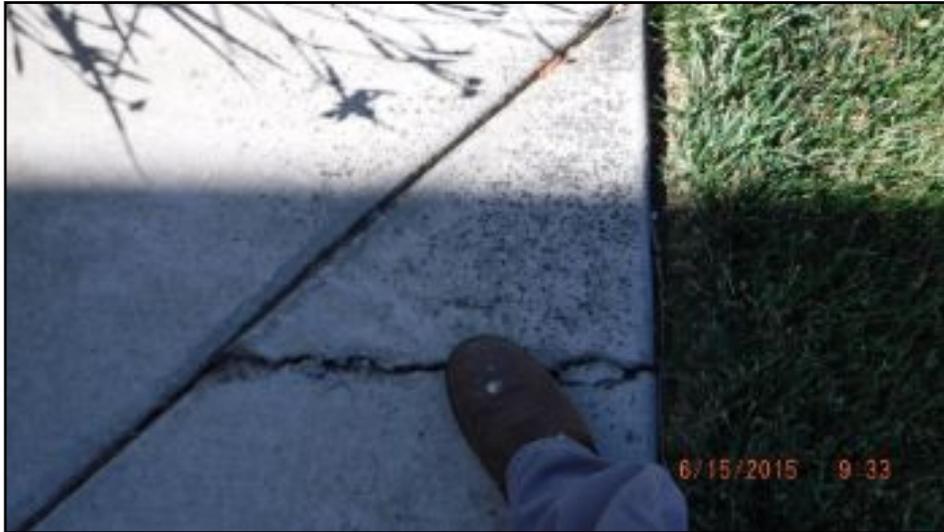
- The walkway at the front is cracked or damaged. This is primarily a cosmetic issue at this time. Over time cracks may enlarge and become a trip hazard. We advise monitoring this area and to consider having a qualified contractor make the appropriate repairs.

typical settlement cracks in concrete walkways

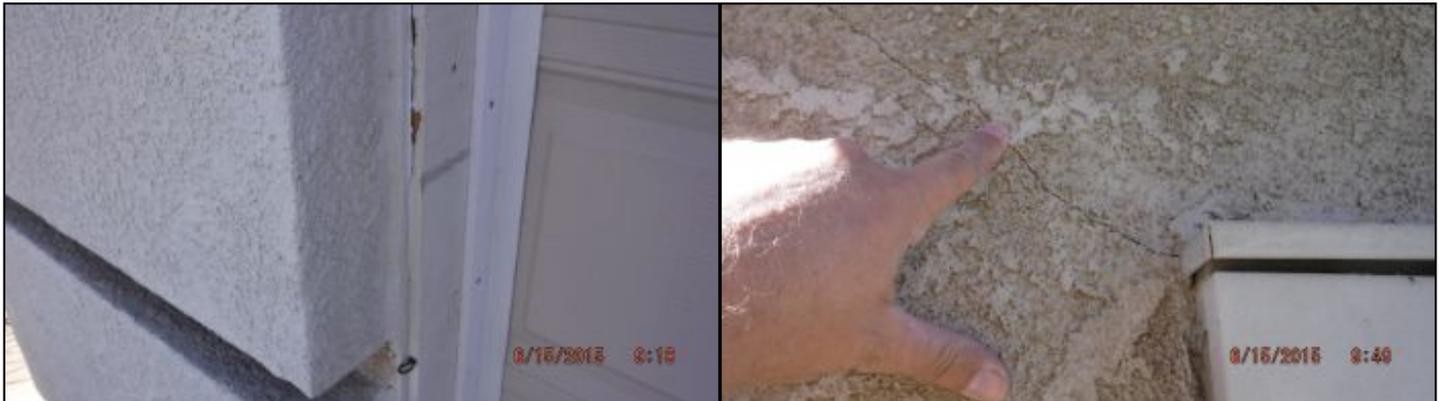
- There are typical, small hairline cracks and small flaws in the stucco in several places. It should be noted that settlement cracking is a common occurrence in stucco wall surfaces and the cracking observed is believed to be typical of that found in the average home of the same age.

- There are some typical gaps between various trim pieces and between trim and siding components around this home. Keeping this home well sealed and painted will reduce water and insect entry. As a part of this home's routine maintenance program these gaps or small voids should be filled with the appropriate caulking.

typical cracks between exterior cladding and trim

typical stucco cracks

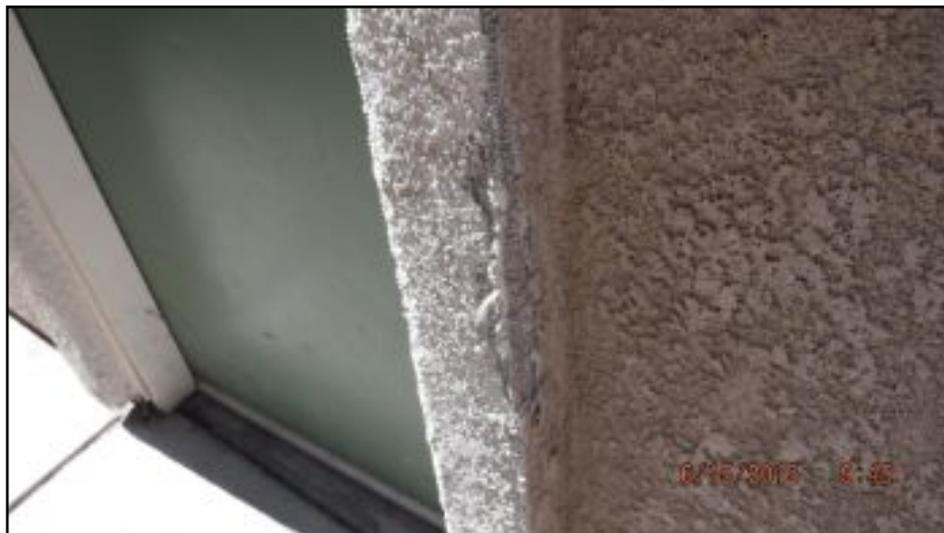
- The fascia and/or bargeboard paint is generally worn, cracking and peeling. These components would benefit from being properly prepared, sealed and painted.

cosmetic damaged trim

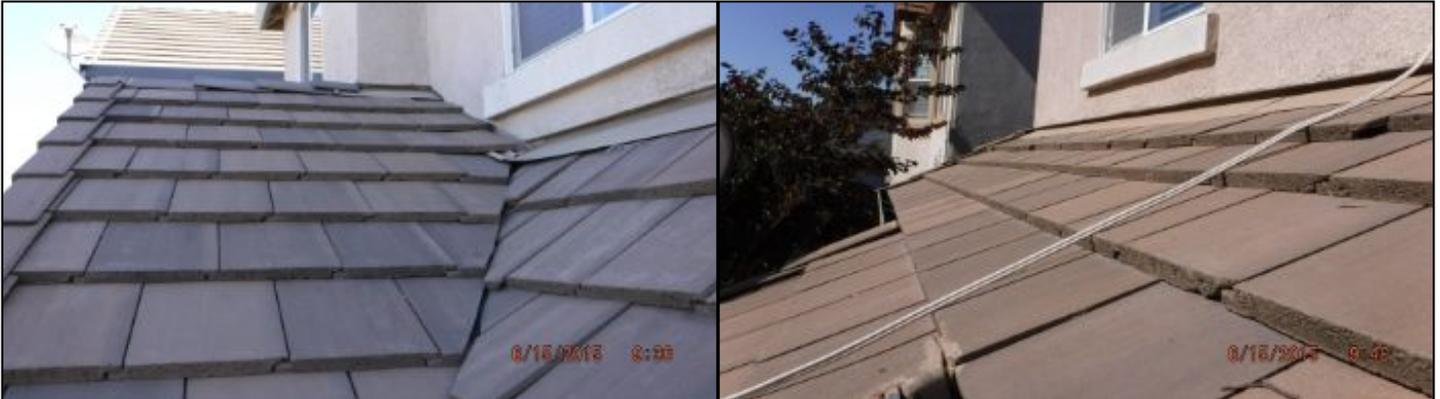
- There is moss, algae or mildew growth on portions of this roof. These organisms accelerate deterioration of the roof surface through secretion of oxalic acid, a powerful corrosive. It is recommended that this roof be properly cleaned by a professional. High-pressure washing of the roof is not recommended, as this can further accelerate deterioration. Instead, the roof should be carefully cleaned using a combination of chemicals and brushing with a soft-bristled brush in combination with a low-pressure rinse of clear water.

roof ok

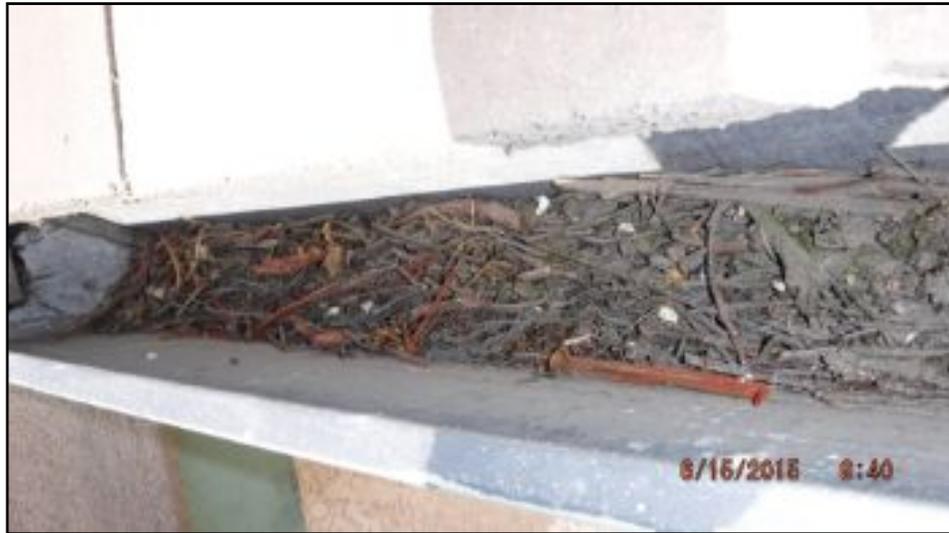
- The gutter(s) at the rear appears to be improperly sloped away from the drop-out - downspout location. This condition does not allow the water to completely drain from the gutters. The standing water is heavy and will cause premature wear and/or corrosion in the gutters. We recommend further evaluation and repairs by a qualified roofing or sheet metal firm.

debris in gutters

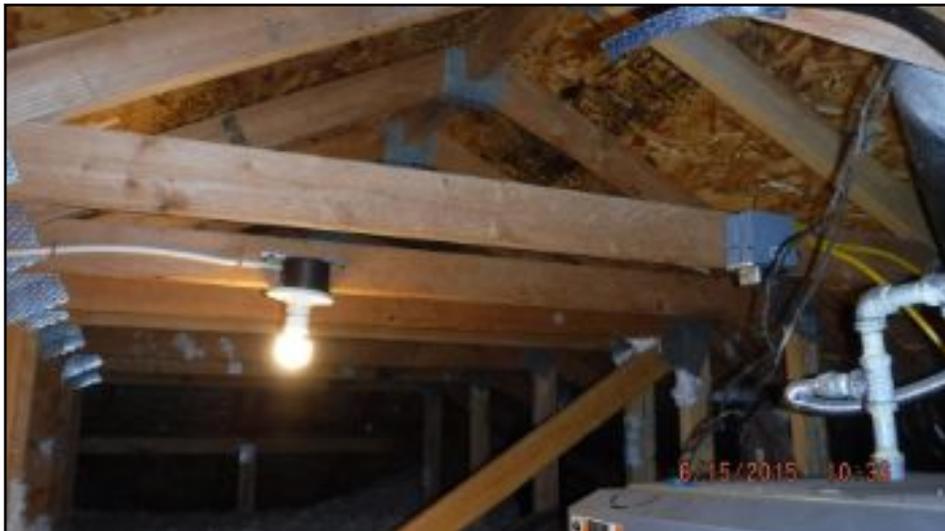
attic framing ok

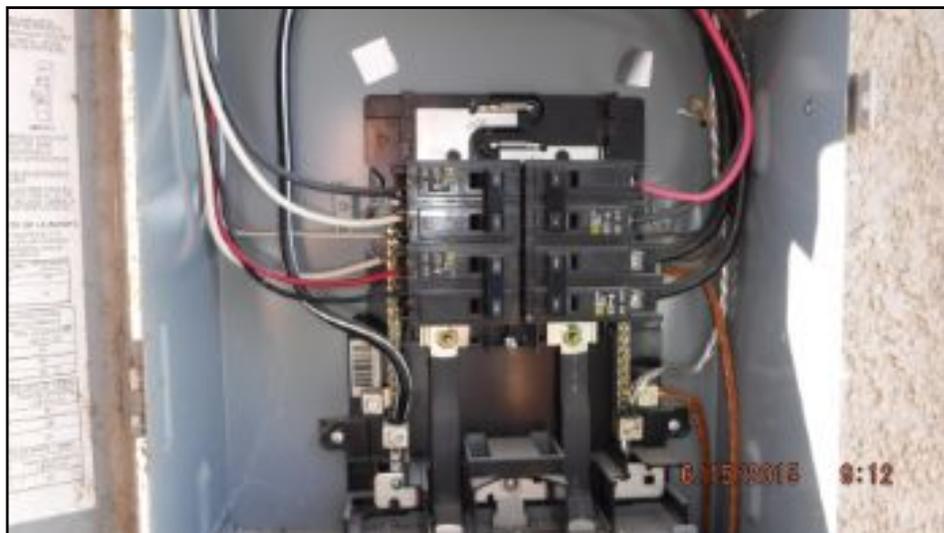
Main panel ok

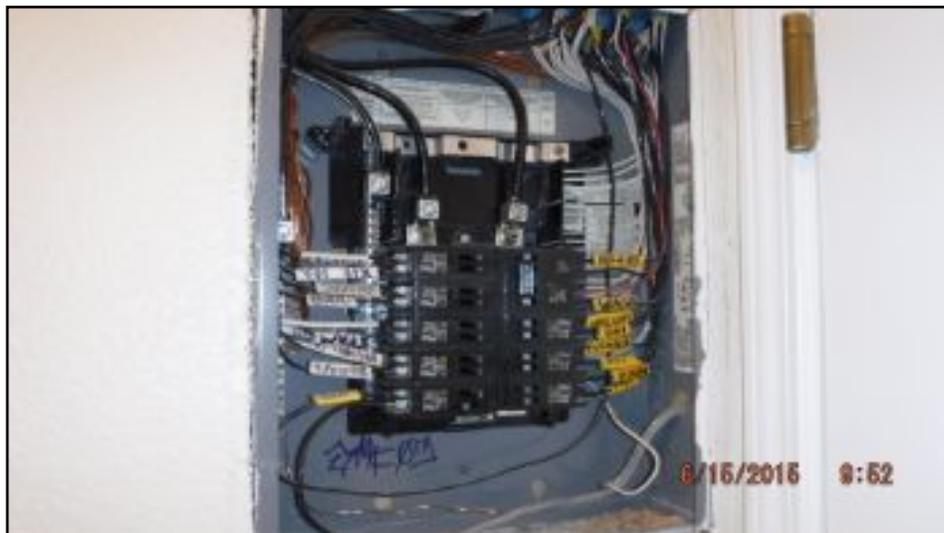
sub panel ok

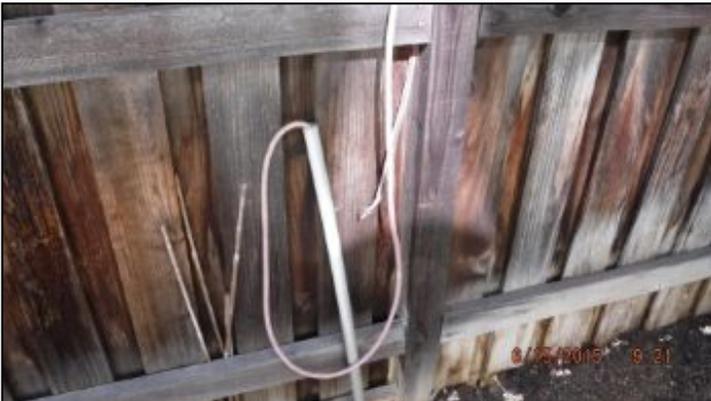
- There is abandoned wiring in the garage and in the access panel for the cosmetic fireplace. Abandoned wiring is a potential hazard and makes future repairs and diagnosis more difficult. We recommend all unused/abandoned wiring be properly removed by a qualified electrician.
- There is some improper wiring at the exterior rear of this home. Please read this entire section carefully for further details. It is beyond our scope to perform a specialized electrical inspection. We recommend further inspection by a qualified electrician.

improper/abandoned wiring

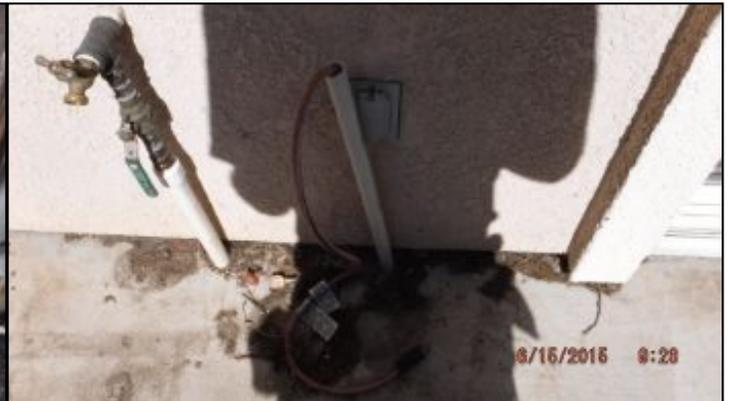
zip cord wiring (improper)

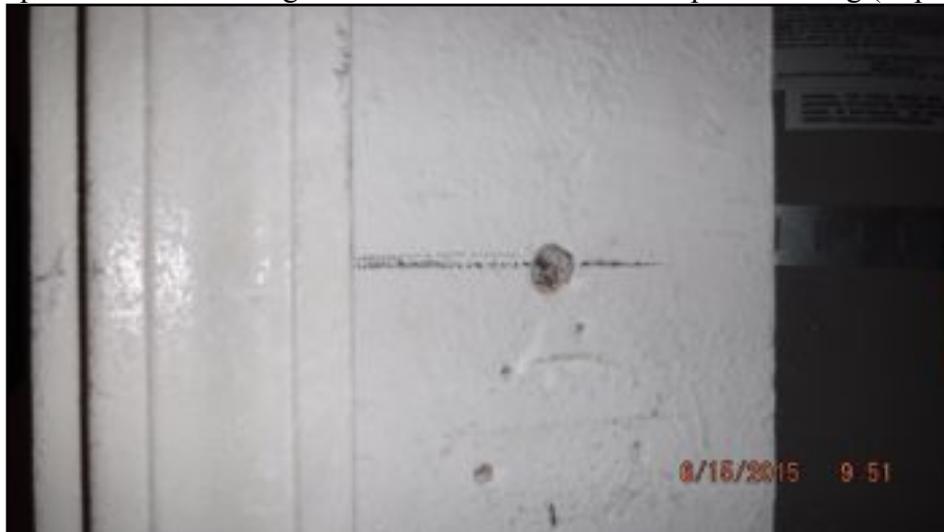
abandoned wiring in garage

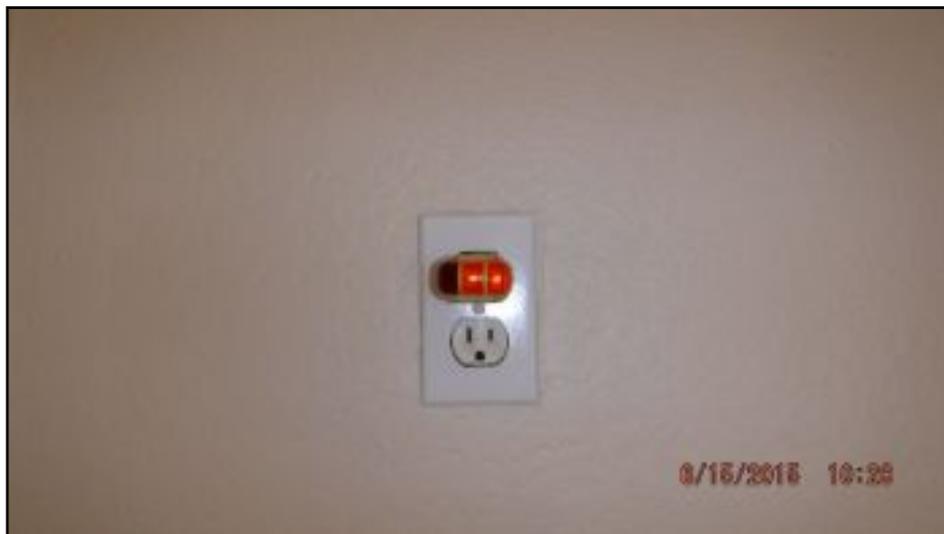
- There is at least one loose outlet in the garage and living room. Loose or improperly secured outlets are a potential fire and safety hazard. We recommend that a qualified, licensed electrician perform further evaluations and repairs.

loose outlet

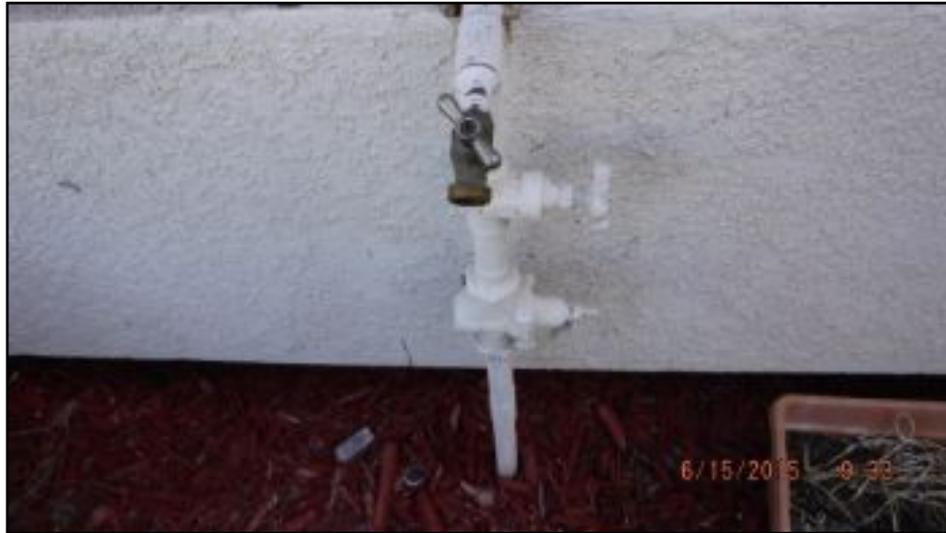
main water shutoff at front

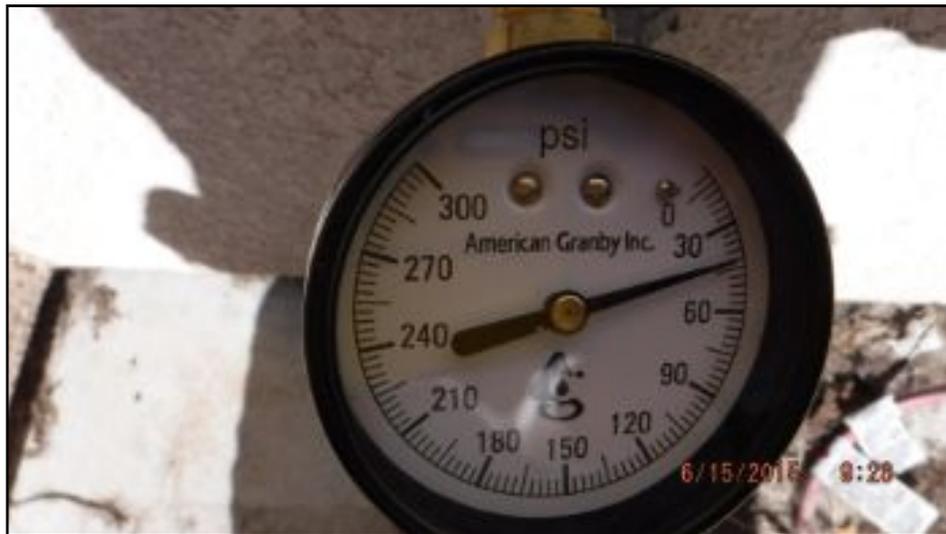
water pressure ok

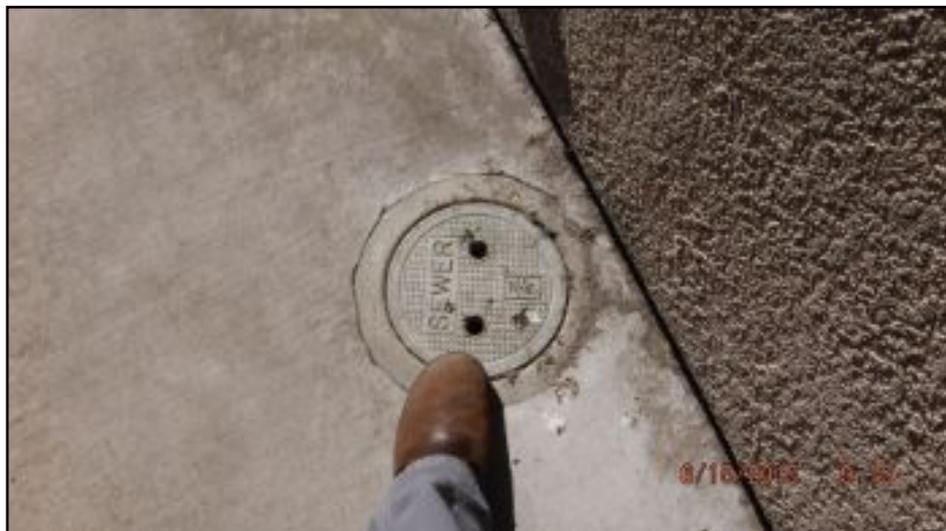
main sewer clean-out at left side

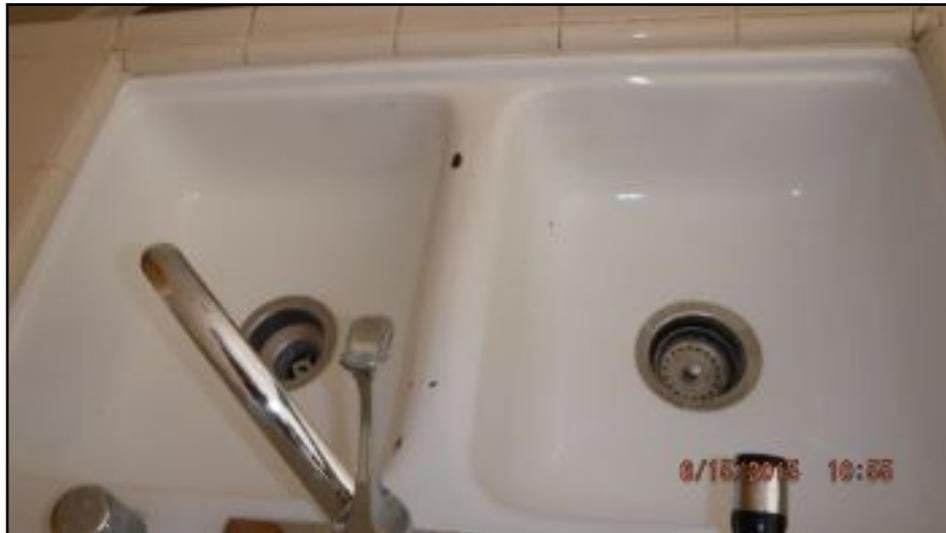
- The kitchen sink is chipped/ damaged and shows wear. Over time these chips in the surface can rust and corrode causing a leak. The sink(s) may need replacement soon. For more information we recommend further evaluation and repairs by a qualified plumber.

kitchen sink moderately worn, note chips

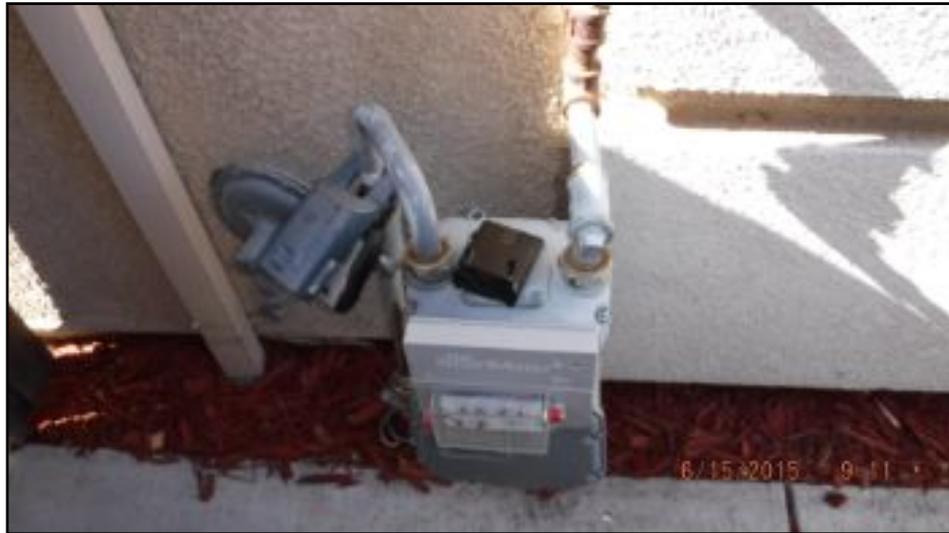
gas meter at left

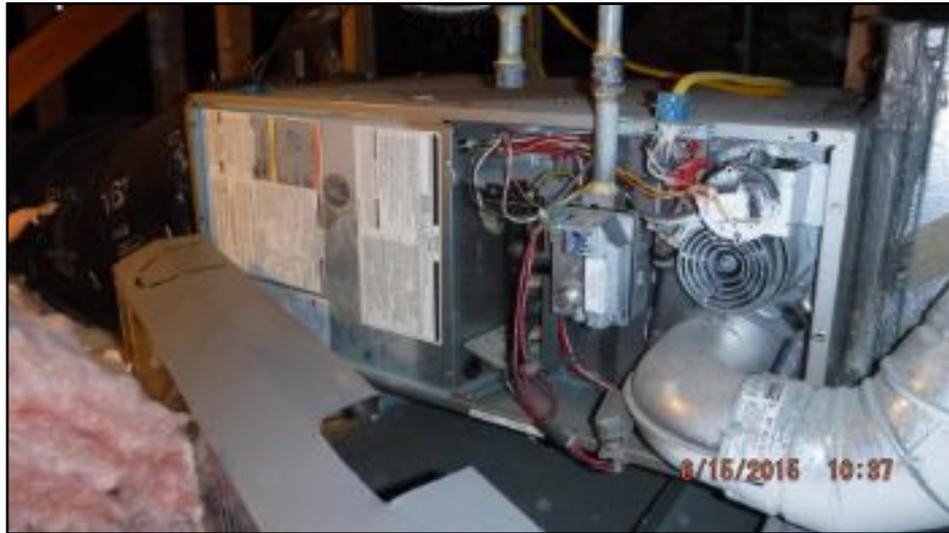
furnace ok

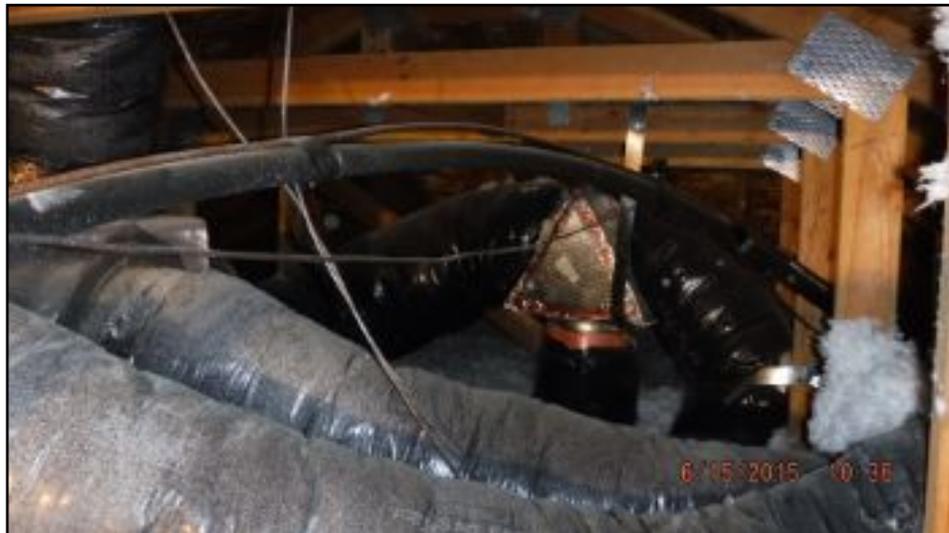
ductwork ok

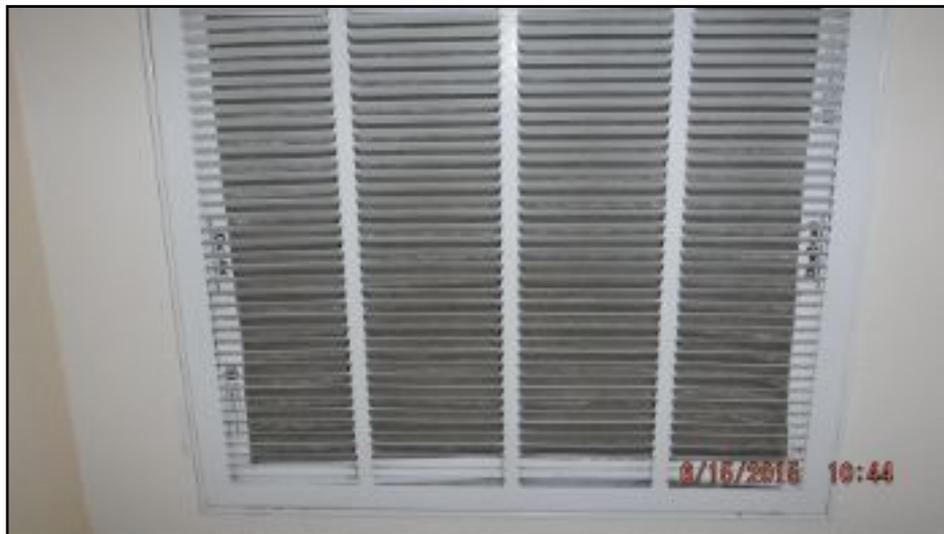
dirty filter

- **MAINTENANCE:** The air filter(s) should be inspected at least monthly and cleaned or replaced as required. There are two types of filters commonly used: (1) Washable filters, (constructed of aluminum mesh, foam, or reinforced fibers) these may be cleaned by soaking in mild detergent and rinsing with water. Or (2) Fiberglass disposable filters that must be REPLACED before they become clogged. Remember that dirty filters are the most common cause of inadequate heating or cooling performance.
- The furnace filter is dirty and should be replaced now. A dirty filter will reduce the efficiency and service life of the furnace.

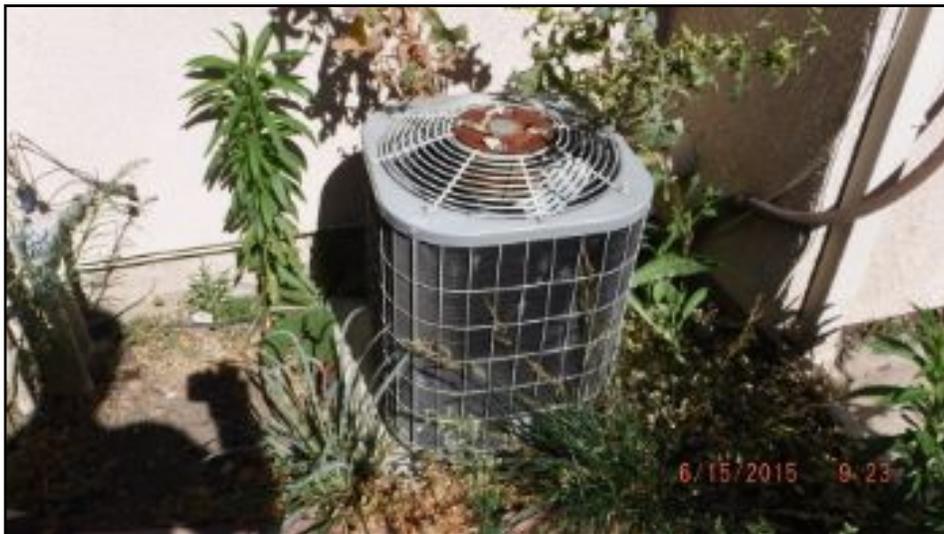
- There is vegetation growing too close to this air conditioning compressor. For maximum efficiency this vegetation should be trimmed back to a distance of at least 12 inches from the sides and 48 inches from the top. We recommend trimming back all vegetation away from the unit.
- The insulation on the suction line for the air conditioner is damaged or missing. Missing insulation will reduce the efficiency of the unit significantly. To achieve the intended level of efficiency we recommend having this (cold) suction line properly insulated.

ac ok

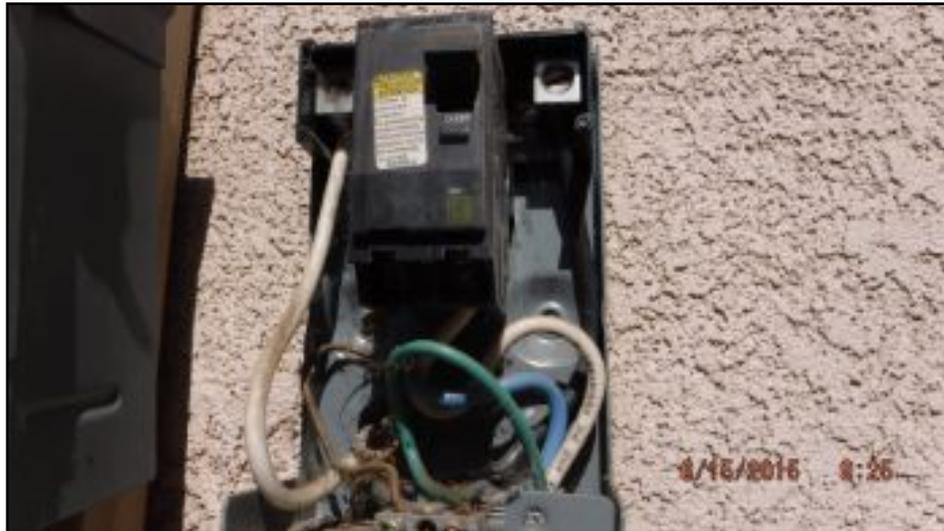
AC disconnect ok

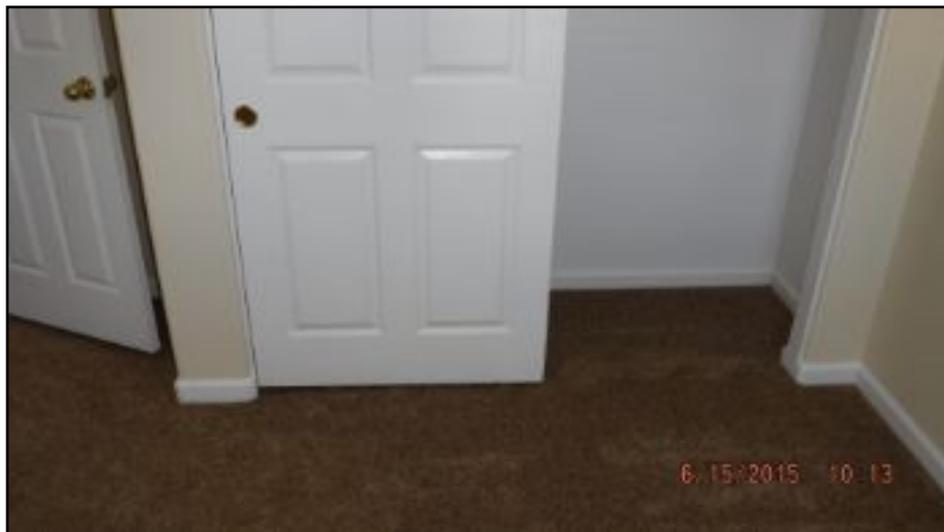
- At least one set of sliding closet doors are missing the lower guide. The lower guide prevents the doors from swinging and potentially coming off the track, possibly injuring persons nearby. We recommend having a qualified handyperson install the missing guide.

missing closet track guides

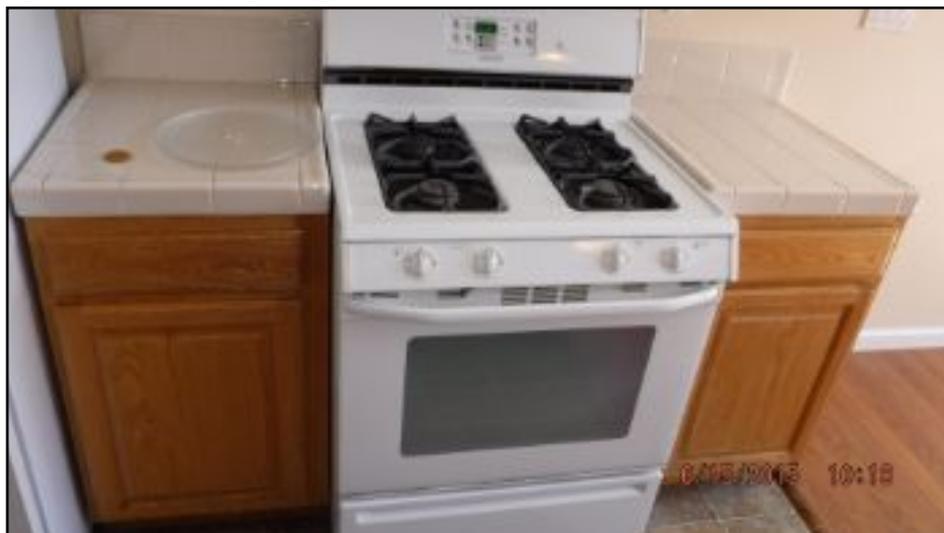
- The oven and range were tested and functioned normally. It is beyond our scope of inspection to test for temperature accuracy or other functions such as self-cleaning, convection fans, timers, etc.
- There is no anti-tip bracket behind/ under the range/oven to prevent it tipping when the door is opened. Anti-tip devices come with new range/ovens and are supposed to be used. Without an anti-tip bracket, the stove could tip away from the wall, spilling its contents. A bracket should be added before using this oven.

oven ok

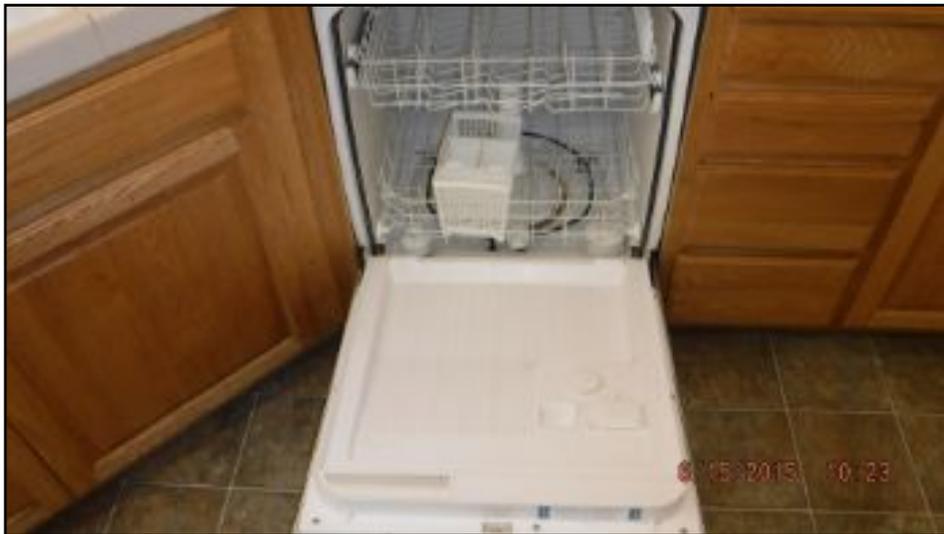
- About air gap devices: The air gap is used for dishwashers to assure separation between the disposer or sink wastewater and the dishwasher. An air gap is usually found mounted to a hole on the sink. It has flexible rubber hoses that run to both the dishwasher and the garbage disposal. If this device leaks when the dishwasher is run this is an indication that the line(s) are clogged or the air gap device is faulty and requires replacement.
- The dishwasher did not work when tested. We recommend further evaluation by a qualified appliance contractor.

dishwasher inoperable

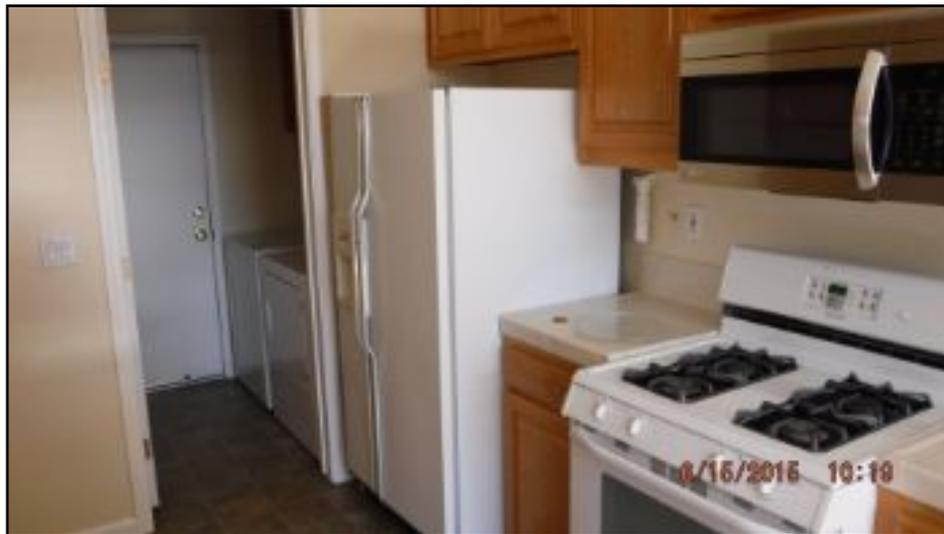
- The refrigerator appears in satisfactory condition. No leaks were observed. It is beyond the scope of this inspection to check the ability of this appliance to cool or freeze foods.

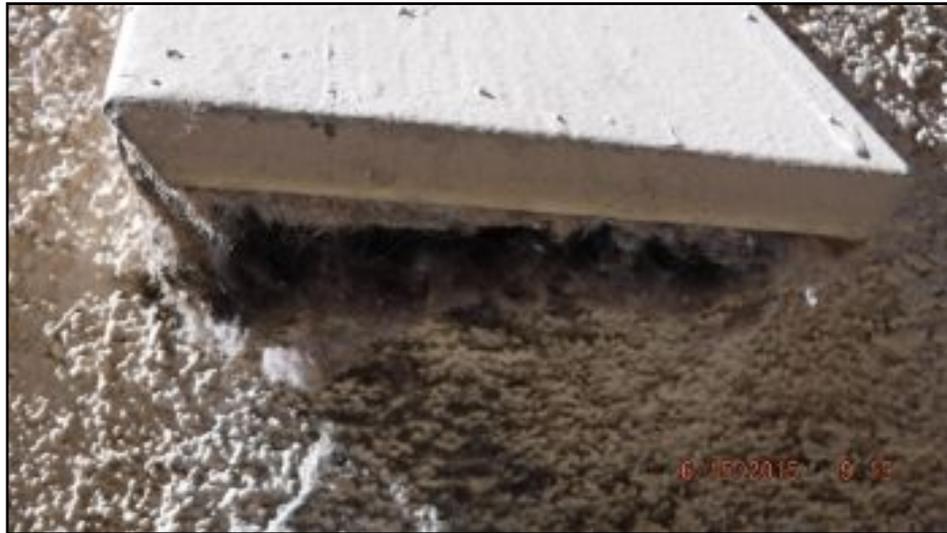
- The clothes dryer vent appears at least partially clogged with lint/debris. This is a potential fire hazard and significantly reduces the efficiency of the dryer. Clothes dryers produce enough heat to ignite dry lint. We recommend clearing this vent then checking the exhaust flow when the dryer is operating.

- The dryer vent is partially occluded/ crushed or damaged. An improperly configured or damaged dryer vent will significantly impede air flow. This condition will reduce the efficiency of the dryer. We recommend considering having a qualified handyperson or contractor properly install a proper dryer vent. Note: solid wall, insulated aluminum or metal pipe 4" diameter pipe should not exceed about 15 feet in length, have minimal bends/turns and terminate at the exterior of the home with either a flapper or a screen to prevent animal entry.

dryer vent and duct needs cleaning

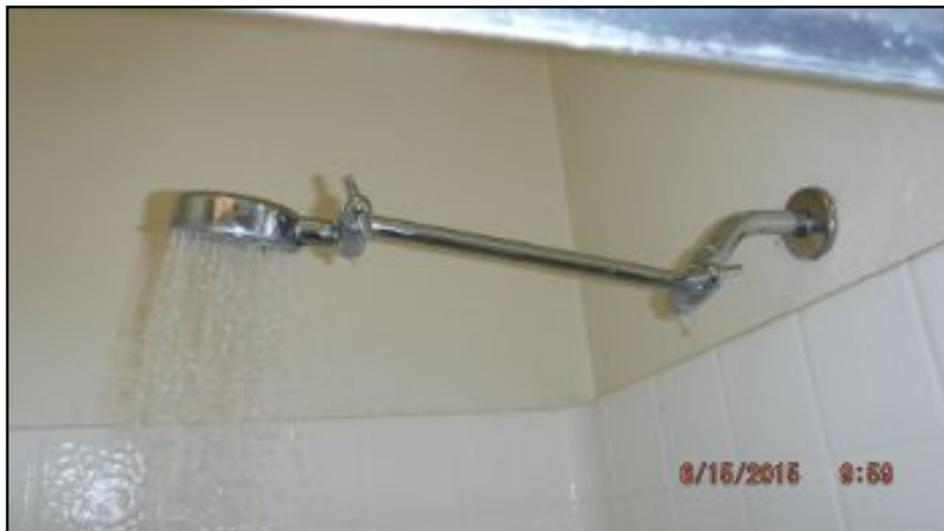
- There is a gap between the shower/ tub surround and the faucet or filler spout. This gap can allow water to enter the wall behind the surface. Water in the framing can cause significant damage. It is unknown if damage already exists in this area or not. We recommend properly sealing these fixtures and/or further evaluation by a qualified pest firm.
- The showerhead in the master bathroom leaks and should be repaired. Water spraying on the wall or on the floor is a primary cause of future moisture related damage. Note: Simply applying Teflon tape to the threads of the shower head/ arm and properly tightening the various nuts will often stop the leak(s).

leaky shower head

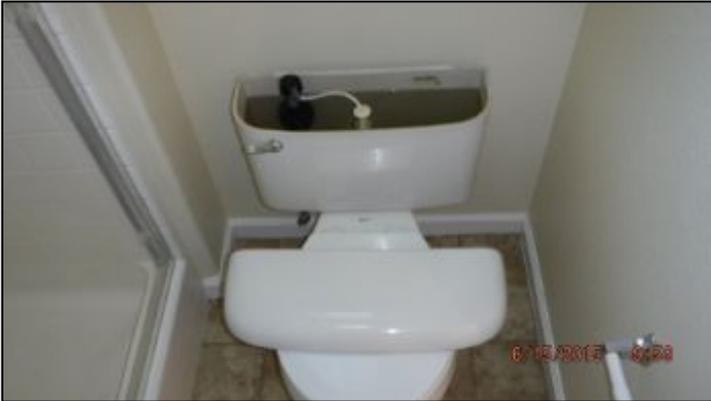
- The toilet in the master bathroom is not working and/ or damaged. Specifically the toilet is not flushing. The unit could not be tested. We strongly recommend further evaluation and repairs by a qualified plumber.
- In the 1/2 bathroom the toilet tank lid is cracked. This unit may completely break if disturbed/ set down. The shards from this unit are sharp and heavy- use caution. We recommend finding a replacement for this toilet tank lid.

inoperable toilet

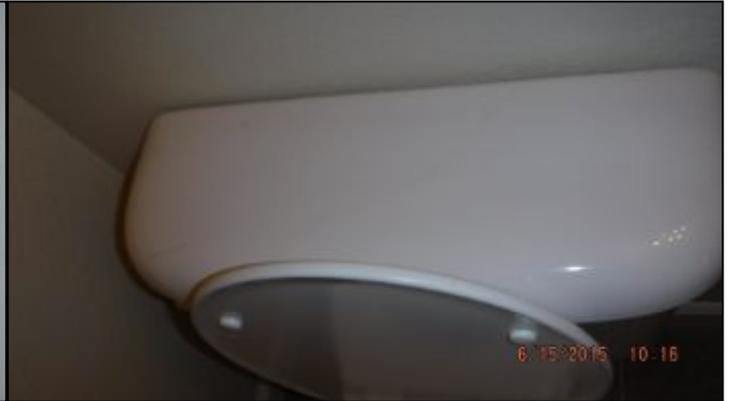
toilet tank lid cracked

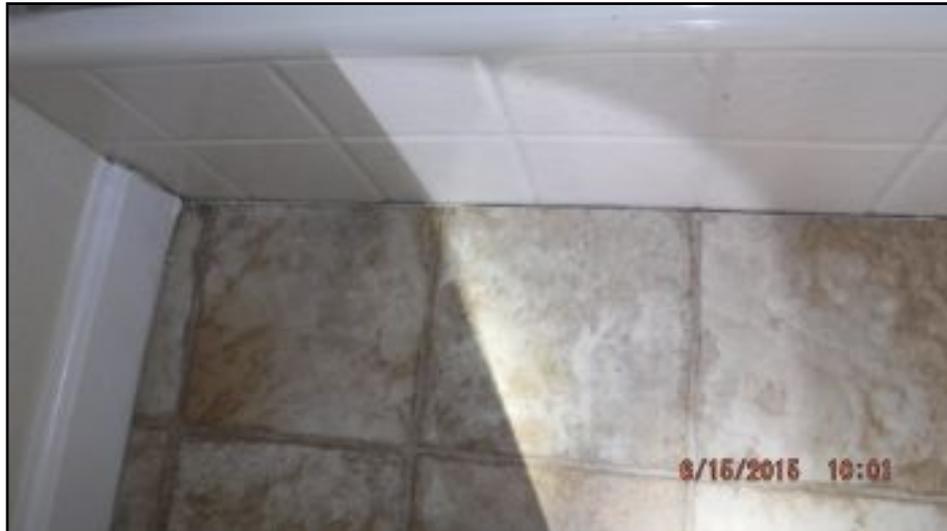
- In the master bathroom and hall bathroom there are some gaps between the shower pan and the flooring. These voids can allow water to damage the wood sub-floor below. As a part of this home's routine maintenance we recommend checking these areas for softness (damage) and keeping these joints well sealed.

gaps at bathroom floors

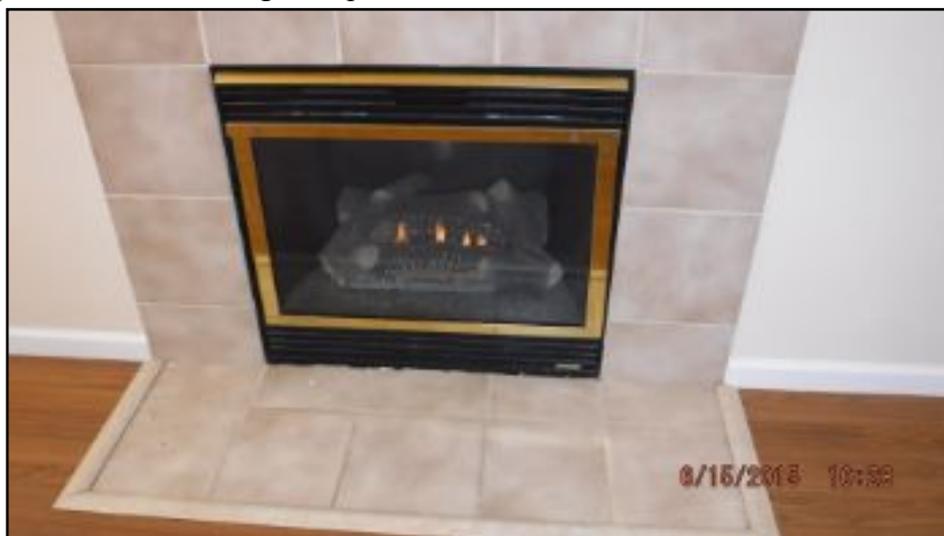
- This home has fired type fireplace(s). This unit cannot burn solid fuels such as wood or presto logs. The unit was switched on and it functioned normally. The fireplace appear in generally good condition. We advise asking the owner for more information regarding maintenance and proper use of this fireplace.
- There is a damper that is functioning as expected.

fireplace ok
